Rail corrugation: a problem solved?

Dr Stuart L Grassie

Kuala Lumpur transit lines

Kajang Line: some basics

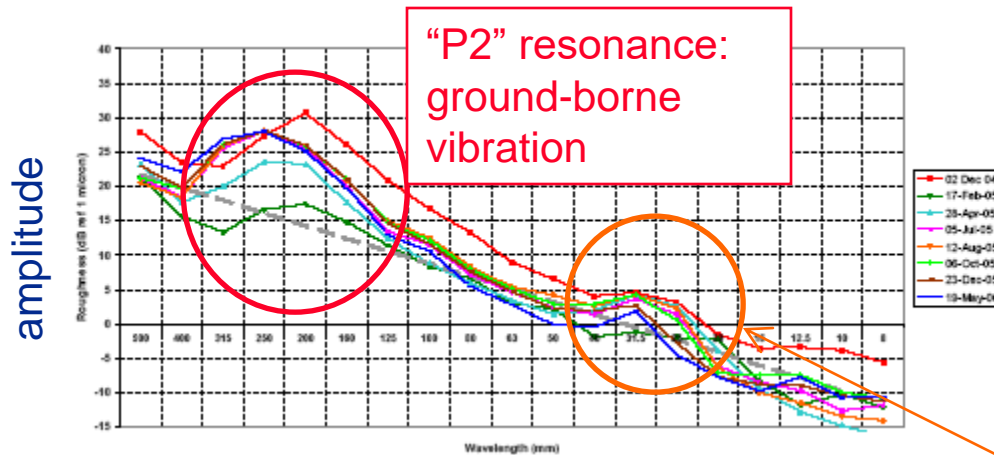
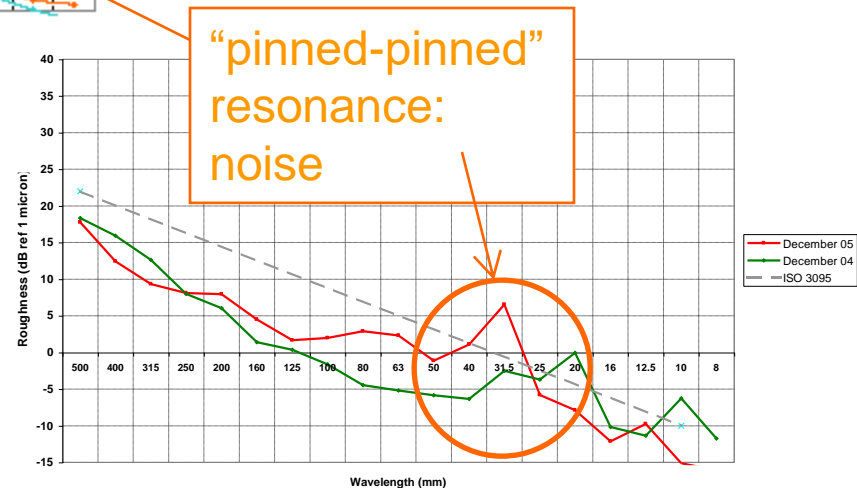
P2 resonance corrugation: presence and absence on the same inter- station section of the same railway line

- “traditional” trackforms
 - corrugation at short and long wavelengths

- very resilient trackform (“Pandrol Vanguard”)
 - corrugation at short wavelength only

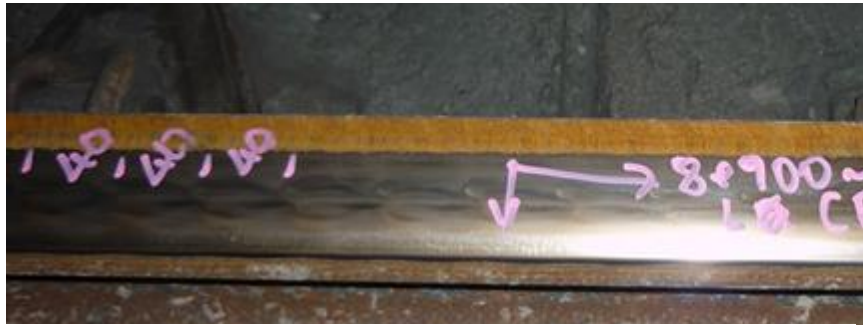
- this has been a severe problem on some new metros
- track here was ground 6 months previously
- typically, this type of corrugation occurs *very quickly* and is extremely periodic

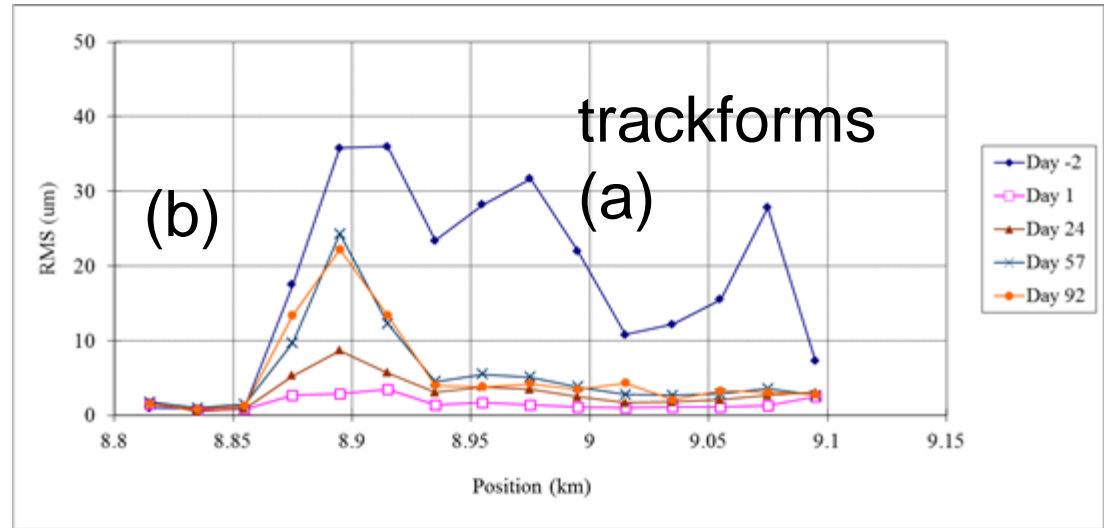
- measurements taken at the site in previous slide
- 57 days (< 2 months) after the site was ground
 - corrugation on trackform (a) developed to >10 times the amplitude of corrugation on adjacent “standard” trackform (b)

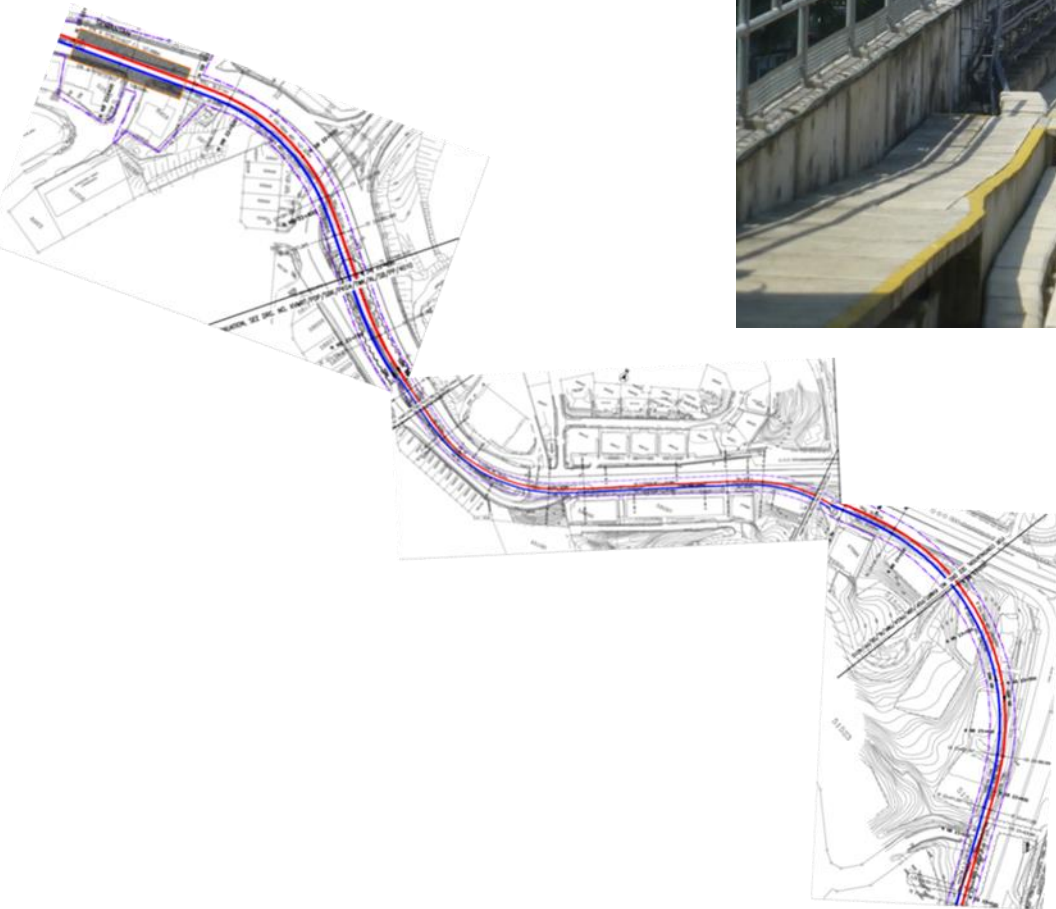
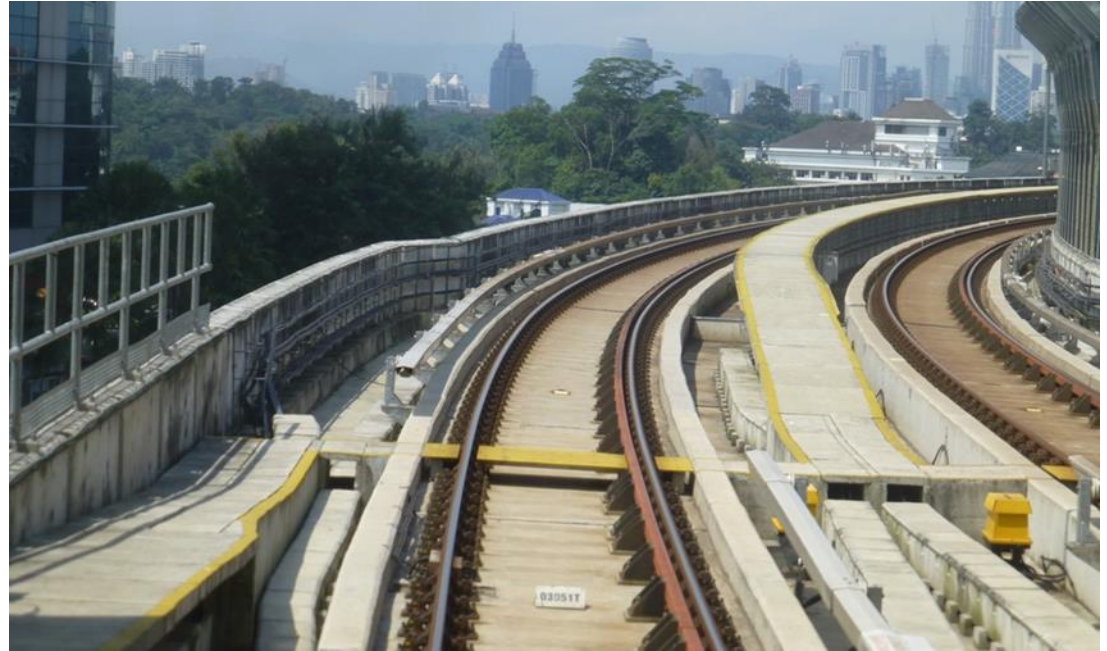
a more
severe site

- very tight curves e.g. 155m
- exit from station
- both trackforms

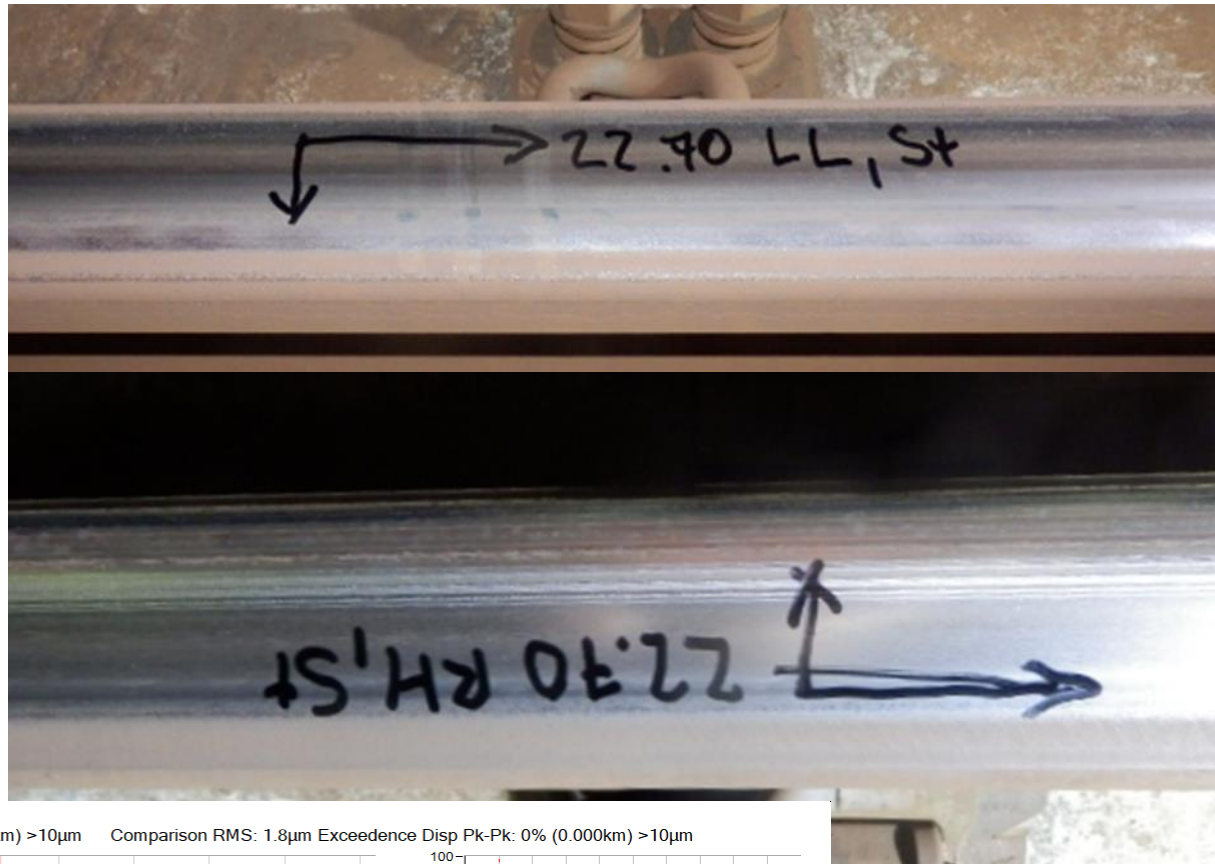
- after 2 years of intensive traffic

Main RMS: 2.6 μ m Exceedence Disp Pk-Pk: 1% (0.010km) >10 μ m Comparison RMS: 1.8 μ m Exceedence Disp Pk-Pk: 0% (0.000km) >10 μ m
